## Hydrologic Impact Index for the Pinhoti Hiking Trail

# **Hydrologic Impact Index for the Pinhoti Hiking Trail**

A Thesis Submitted to the  
Graduated Faculty of Jacksonville State University  
in Partial Fulfillment of the  
Requirements for the Degree of  
Master of Science  
with a major in Geographic Information Science and Technology

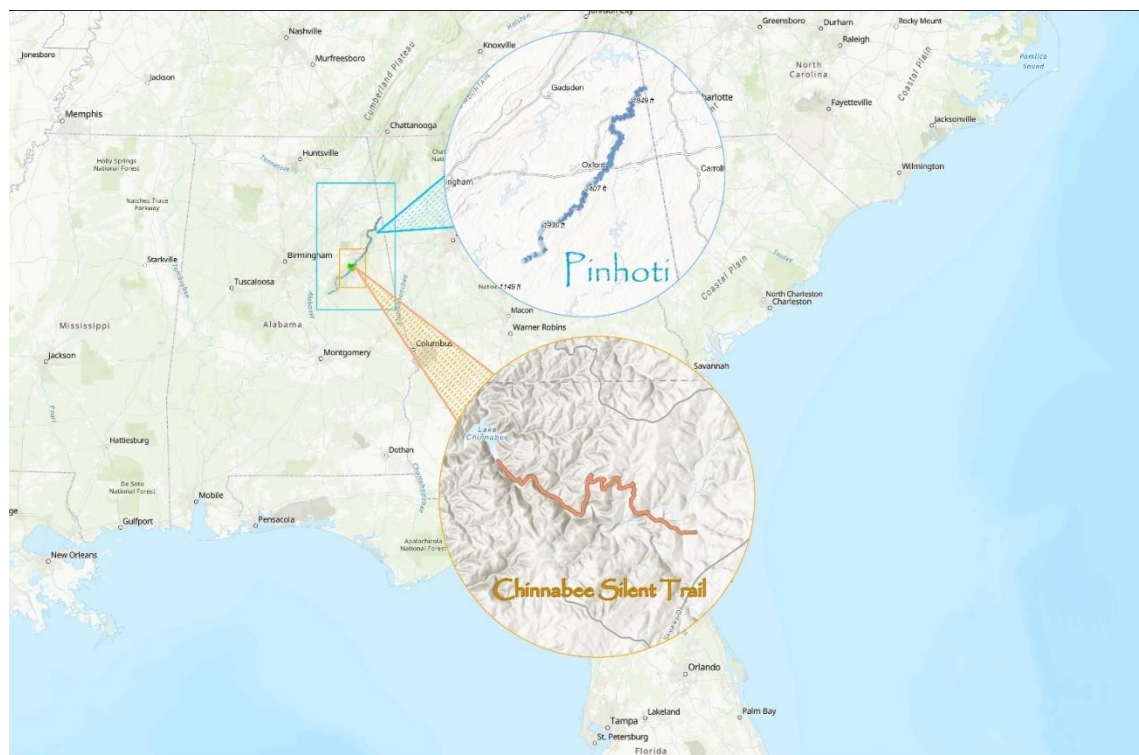
**Figure 1.** The Pinhoti Trail and The Chinnabee Silent Trail of Alabama

It starts at Cheaha Creek and goes for six miles with the last portion of the trail ending at Caney Head atop Talladega Mountain (Forest Service. (2001).

is located in the Talladega National Forest, in Cheaha Mountain, which is the Study area **Fig 1**.

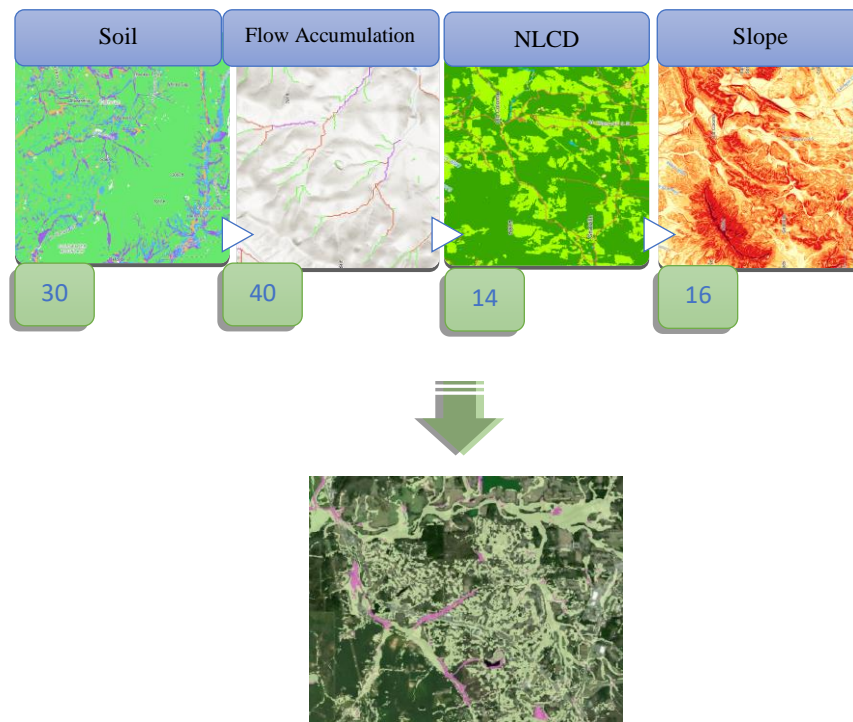
**Figure 18.** Weighted Sum layers and the result

The datasets shown in **Fig 18** were ranked based on their impact on flooding and other hydrology issues. They were then weighted together to determine their contribution to flooding and other hydrology issues in each area. The weights are initially calculated using the Analytical Hierarchy Process (AHP) calculator, which is a mathematical method that assists decision-makers in determining the priority weights for criteria. (Goepel, K. D, 2022).

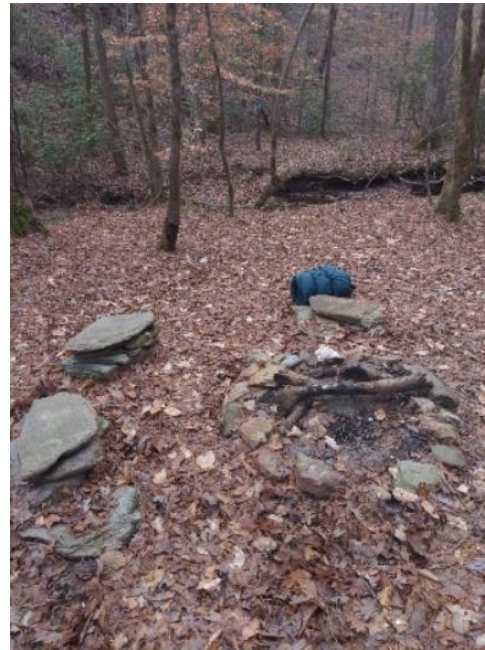
**Fig 22.** Area 1 Campsite (Photo Credit: Allie Field, Jacksonville State University Trails Science Institute)

Located on the Pinhoti Trail, coordinates Latitude 33.543523 Longitude -85.753007, is surrounded by two crossings of Hillibee Creek, where one must cross to continue the Pinhoti Trail. This information from the map is based on ground truthing and from areas near streams and on identifying with older data of special flood zones known as the 100-year floodplain (Zheng, X et. al 2018). This data alone is based on historical evidence and ground truth.

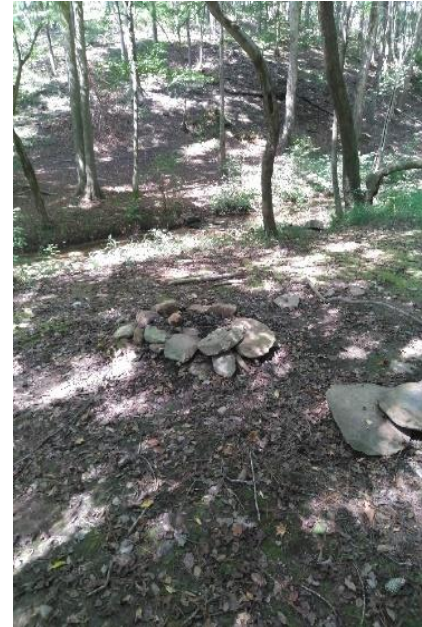
**Figure 28.** Area 2 Campsite by Shoal Creek (Photo Credit: John Graffeo)

Located on the Pinhoti Trail, coordinates Latitude 33.748761 and Longitude -85.579964, is a campsite that is downhill from a stream that flows into Shoal There are several fallen trees surrounding the area, which could indicate a potential risk of water runoff into the creek. This water could saturate the soil around the trees and cause the root systems to weaken over time, resulting in waterlogged or root rot trees.

Additionally, wind may cause them to fall during this process.

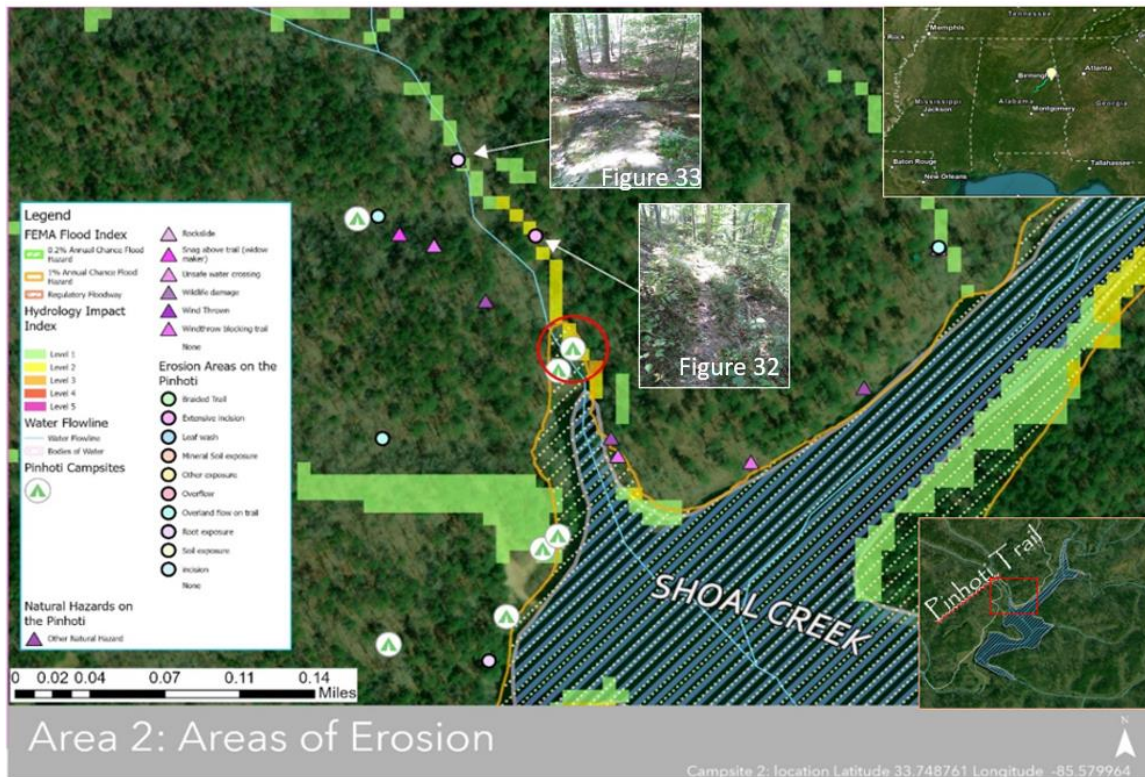
**Figure 31.** Area 2 Campsite Areas of Erosion and Creek Crossing (Photos Credit: John Graffeo, Jacksonville State University Trails Science Institute)

According to the FEMA Flood Zone map the campsite is also located in a “1% Annual Chance Flood Hazard”. Meaning that there is a 1 percent chance within that year of a flood to occur in that location (*The 100-year flood completed. The 100-Year*). This is also called the 100-year flood plain (*Flood zones. FEMA.gov*). With Flooding, there will be a higher indication of erosion such as in **Fig 31**.

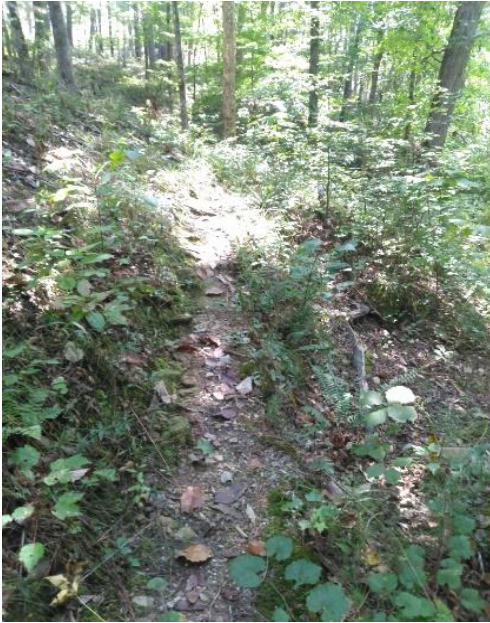
**Figure 32.** Trail Eroding (Photo Credit: John Graffeo, Jacksonville State University Trails Science Institute)

In **Fig 32** the image of the trail is eroding in the area above is the stream that goes down the trail and to Shoal Creek **Fig 33**.

Also, near the Campsite some trees were windthrown **Fig 34, Fig 35, Fig 36**. In both **Fig 34** and **Fig 35**, they are both next to the creek where water can rise and take soil away. In **Fig 34**, it is also below where the stream meets Shoal Creek, so that can also cause the area to erode quicker since it is also noted that portions of the trail were eroding **Fig 32** by the water crossing in **Fig 33**.

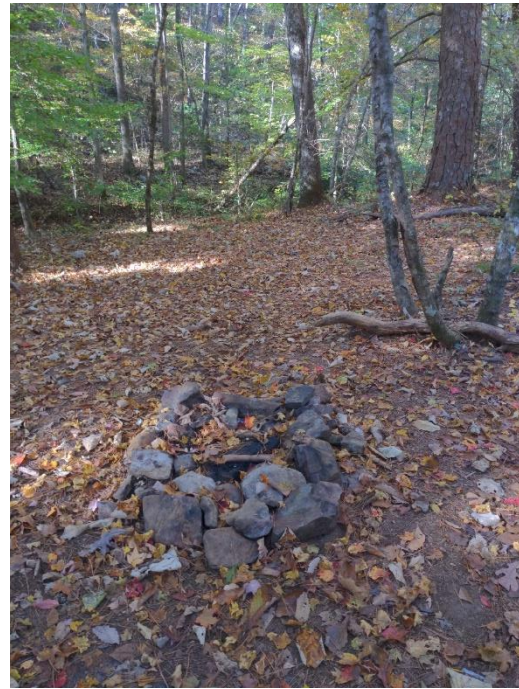
**Figure 37.** Area 3 by Terrapin Creek (Photo Credit: Allie Field, Jacksonville State University Trails Science Institute)

Located on the Pinhoti Trail, coordinates Latitude 33.878118 Longitude -85.551654, is located by Terrapin Creek **Fig 37**. This area is in the FEMA Flood map and the Hydrology Impact Index Data layer. This area has a history of flash flooding. However, prior to collecting data on hydrology damage or reports of flooding, there were no concerns about the flooding. This was because there wasn't much residential development in the area, and dams had been built to help mitigate the flooding. The area was primarily used for agricultural and livestock purposes. However, it was reported in previous years that the creek was known as "untamed" due to the flooding, which caused water runoff and erosion, changing the landscape that surrounds the creek. It was also reported that the flooding even covered the roads to where wagons could not pass, which was the reason for the dams being built (Rome News Tribute. (2009). In 2017 it was reported that the creek flooded due to a higher amount of rainfall, which is the same reason that Hillabee and Choccolocco Creek also flooded in 2022 (Cooper, A., 2017).

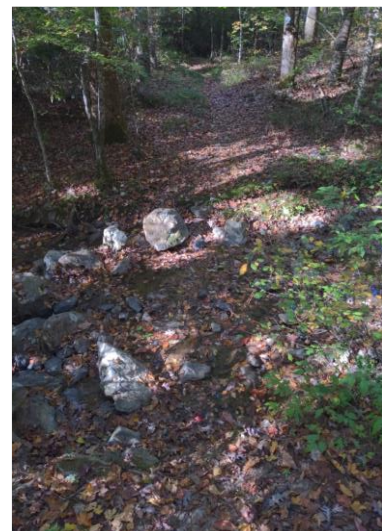
**Figure 39.** Overflow erosion near area 3 (Photo Credit: Allie Field, Jacksonville State University Trails Science Institute)

an overflow on the trail from the creek. This is due to water that overflows from a river or stream and carries away excess soil and sediments. This occurs with heavy rainfall. In **Fig 39** we can see the small portion of damage erosion causes, but over time it puts the landscape at risk for loss of soil fertility since the top layer of soil is washed away, and essential nutrients and minerals are also carried away, overflow erosion can also lead to landslides, especially in higher terrain areas. As the soil becomes loose and unstable due to erosion, it is more susceptible to mass movement. This can be dangerous for communities living in these areas and can result in loss of property and even lives (Takayama, S., & Imaizumi, F.. 2022).

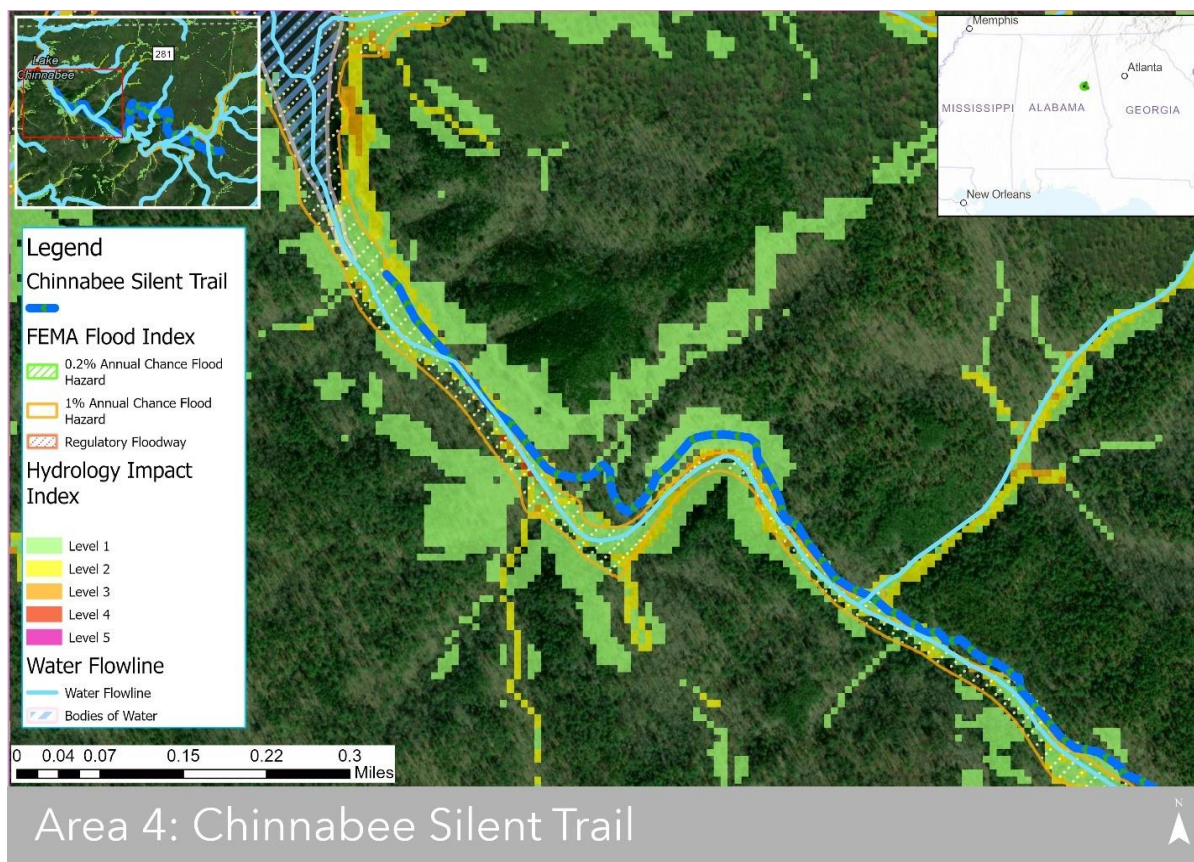
**Figure 43.** Area 4 Chinnabee Silent Trail and Hydrology Issues

The Chinnabee Silent Trail is also located in the Talladega National Forest. It starts at Cheaha Creek and goes for six miles till the last portion of the trail ends at Caney Head atop Talladega Mountain at Lake Chinnabee (*National forests in Alabama - Chinnabee Silent Hiking Trail*). In **Fig 43** we can see the portion where Lake Chinnabee is in a FEMA flood zone and Level 1- 3 on the Hydrology Impact Index Data. This area is located in a flood-prone zone. The campground had to be closed down in 2013 due to flooding, as there was a concern for the safety of the visitors. The flash flooding occurred at night, which caused anxiety for the outdoor enthusiasts. (Nielsen, G., 2013).

On the Lake Chinnabee Recreation flood damage was done due to the flash flooding that closed this location's campgrounds (Nielsen, G. 2013, May 22). I found the images on Whiteblaze, by OwenM, who went hiking on New Year's Day of 2013 at Chinnabee Silent Trail. He claims, "Would have been a rude awakening for anyone camped along the creek... These are from New Year's Day. I day hiked the Chinnabee from Turnipseed, plus the Lakeshore Trail. From the debris, and state of the trees, the creek looked like it would have had to have gone from the familiar stream to being 50-60ft wide and 10ft deep." (M, Owen., 2014, March 5), where users were talking about the location being reopened for camping, but concerns are still out there about the risk of flooding.

Area 4 on the Chinnabee Silent Trail **Fig 43** is prone to flooding and ranks Level 1-3 on the Hydrology Impact Index Data, leading to the closure of the campground in 2013. Flooding can be dangerous, especially for campers at night.
